# ROCKY MOUNTAIN STEEL PIERING INCORPORATED

## CASE STUDY

**Project:** Martin Residence, Aurora, Colorado

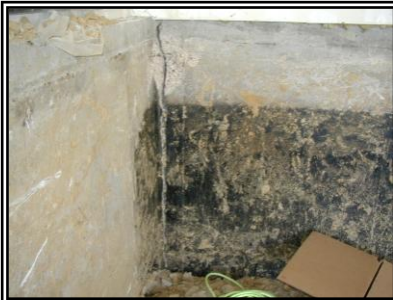
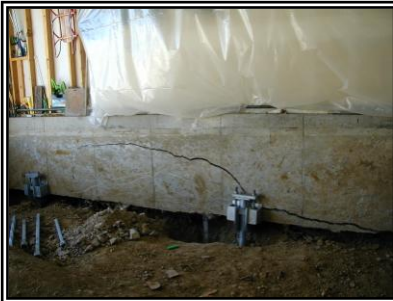
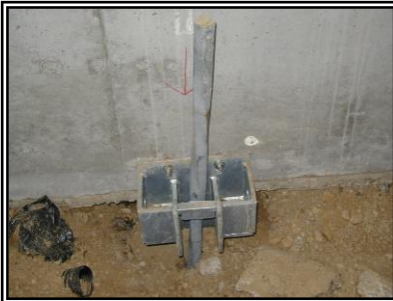
The home consists of a one-story structure with partial basement and partial crawlspace, supported on a drilled concrete pier foundation system. The majority of the home experienced differential vertical foundation movement, which has caused foundation wall cracks, door operation problems and drywall distress to the home.

The repair to the affected foundation system consisted of installing helix piers along the foundation walls, clipping and detaching the existing concrete piers from the foundation, re-leveling the foundation, re-voiding the foundation walls, installing an interior perimeter drain system and repairing the foundation wall cracks. The helix piers were installed by Rocky Mountain Steel Piering, Inc., utilizing a portable torque head to advance the piers into the ground. The helix piers were 1-1/2-inch rounded corner square steel shafts with a single 8-inch helix near the base of the lead section. The tops of the piers were attached to standard underpinning brackets, which were fastened to the base of the foundation walls, and to new construction brackets, which were embedded in reinforced concrete beams at each column location. After the piers were installed and fastened to the foundation walls, the tops of the existing concrete piers were clipped, the foundation was re-levelled as much as possible, and the base of the foundation walls were re-voided. An interior drain system was installed to prevent water accumulation below the foundation system.
