# ROCKY MOUNTAIN STEEL PIERING INCORPORATED

## CASE STUDY

**Project:** Young Residence, Littleton, Colorado

**Underpinning Contractor:** Rocky Mountain Steel Piering, Inc.

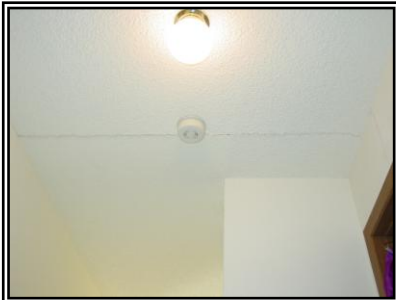
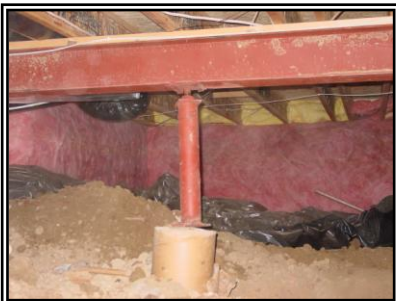
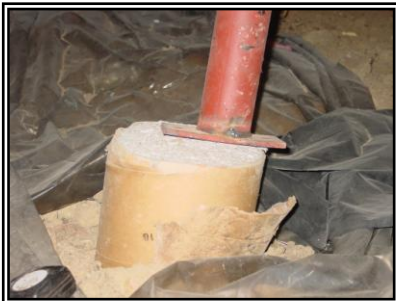
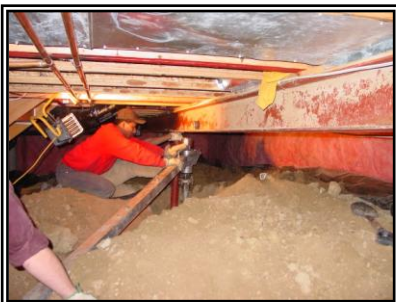
The home consists of a two-story structure with a partial basement along the east portion of the home and partial crawlspace along the west portion of the home. The foundation system supporting the foundation walls and interior steel columns consists of a drilled concrete pier system. The two adjustable steel columns within the crawlspace were found to be inadequate to support their intended loading due to the columns being severely out-of-plumb. The columns were also bearing on the outside portion of the drilled concrete piers below. Due to the apparent leaning of the columns, significant distress was observed within the living space above this area.

The repair to the affected columns within the crawlspace consisted of installing helical steel piers at each adjustable steel column location and bracing the steel support beams above. The helix piers were installed by Rocky Mountain Steel Piering, Inc., utilizing a portable torque head to advance the piers into the ground. The helix piers consisted of 1-1/2-inch rounded corner square steel shafts. The south-most pier consisted of a single 8-inch helix pier, which was advanced approximately 43 feet into the ground. The north-most pier consisted of a double (8-10) helix pier, which was advanced approximately 28 feet into the ground. The piers were advanced to a minimum torque of 4000 ft-lbs as specified. The torque was verified by utilizing a pressure dial gauge, which was attached to the hydraulic foot control for the torque head. The tops of the piers were fastened to pier brackets, which were encased in a concrete pier cap. After the piers were installed, new adjustable steel columns were installed and the support beams were braced.
